FORENSIC ENGINEERING — BENLD ELEMENTARY SCHOOL ILLINOIS DEPARTMENT OF NATURAL RESOURCES

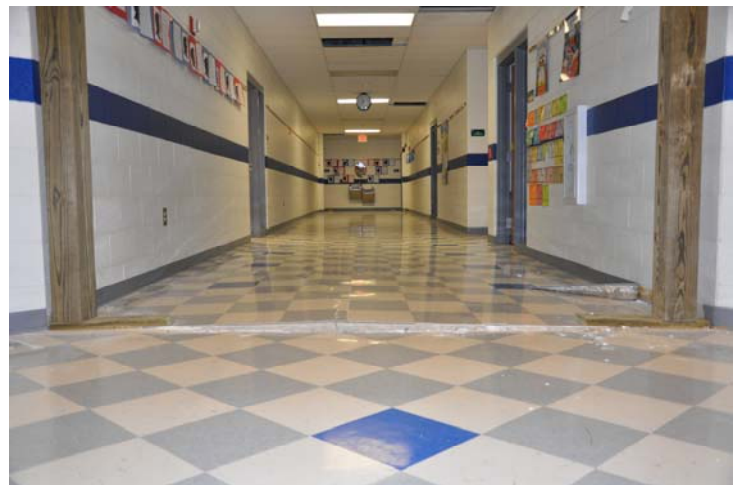
CHANGES IN THE FLOOR SURFACE - BENLD, IL

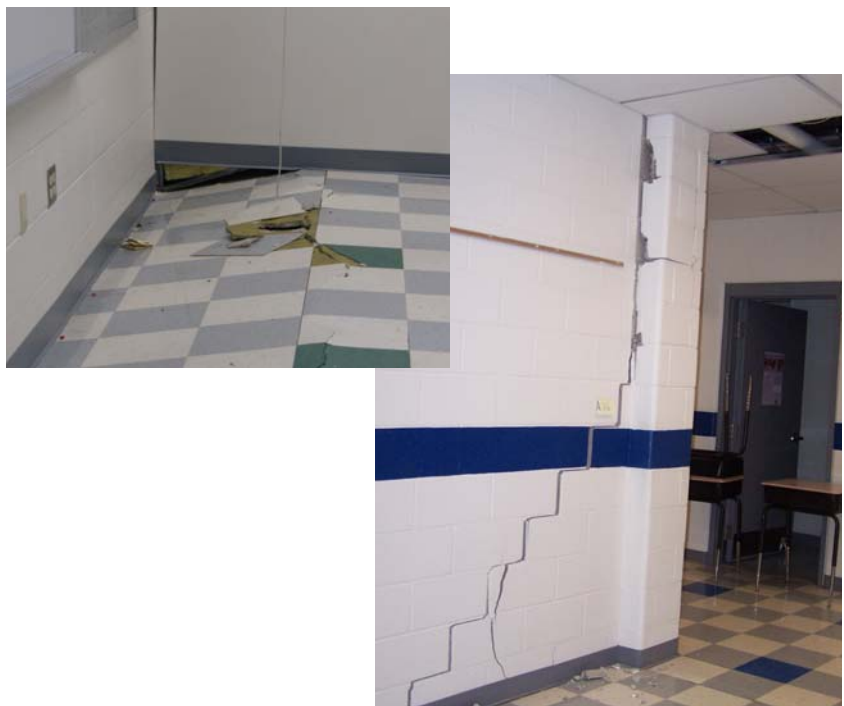
FLOOR AND WALL CRACKING - BENLD, IL
