# FORENSIC ENGINEERING — WAREHOUSE ROOF FAILURE DUQUOIN, ILLINOIS

*The roof of a warehouse collapsed following a torrential rain storm. The insurance adjustor required assistance to determine the root cause of the failure along with an assessment if the facility could be re-constructed on the existing walls and foundations.*

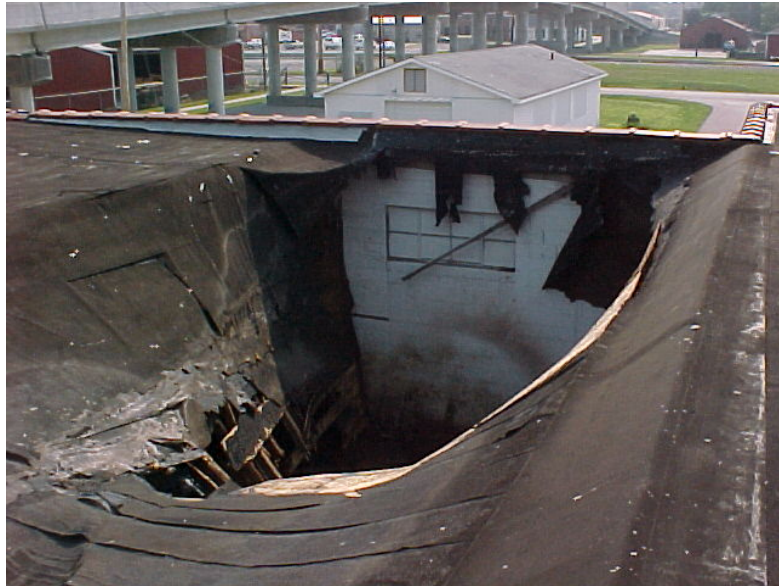
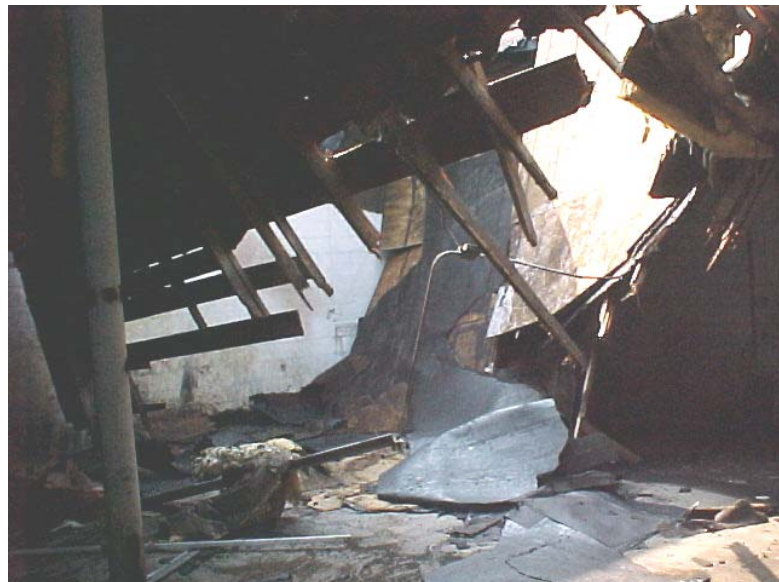
- In this case, the cause of the failure was due to long term moisture infiltration and deterioration.
- The collapse was caused by water ponding on the deteriorated roof.
- The walls were salvageable and a new roof was re-constructed on the existing walls and foundations
